**DEPARTMENT OF TRANSPORTATION****DIVISION OF ENGINEERING SERVICES**

Contract #: 04-0120F4Cty: SF/ALA Rte: 80 PM: 13.2/13.9File #: 69.28**WELDING INSPECTION REPORT****Resident Engineer:**Pursell, Gary**Address:** 333 Burma Road**City:** Oakland, CA 94607**Report No:** WIR-002806**Date Inspected:** 22-May-2008**Project Name:** SAS Superstructure**OSM Arrival Time:** 630**Prime Contractor:** American Bridge/Fluor Enterprises, a JV**OSM Departure Time:** 1530**Contractor:** Zhenhua Port Machinery Company, Ltd (ZPMC), Changxing Island **Location:** Shanghai, China

On this date, Caltrans Office of Structural Material (OSM) Quality Assurance (QA) Inspector Joselito Lizardo was present as requested to perform observations on the fabrication of Orthotropic Box Girder (OBG) and SAS Tower at Zhenhua Port Machinery Company (ZPMC) facility at Changxing Island, in Shanghai, China.

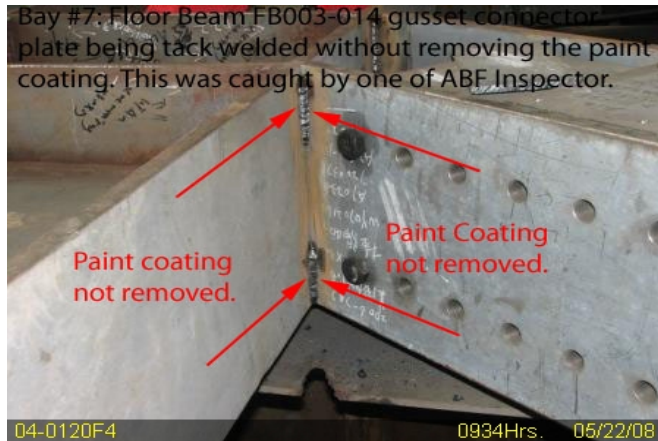
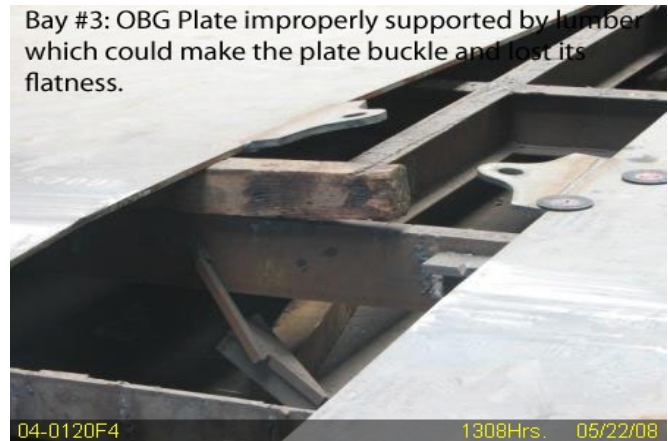
AS shown on two photos below, this QA Inspector randomly observed two incidents wherein butt spliced floor beam plates are supported with 4" X 4" lumber at one side and at the middle of the plate length making the plates buckle and lost its flatness. This incident has called the attention of ZPMC/QC and they addressed it by removing the lumber in question and laid the plates flat.
